AFML-TR-78-160
Volume I

COST EFFECTIVE REPAIR TECHNIQUES FOR TURBINE AIRFOILS

GENERAL ELECTRIC COMPANY

NOVEMBER 1978

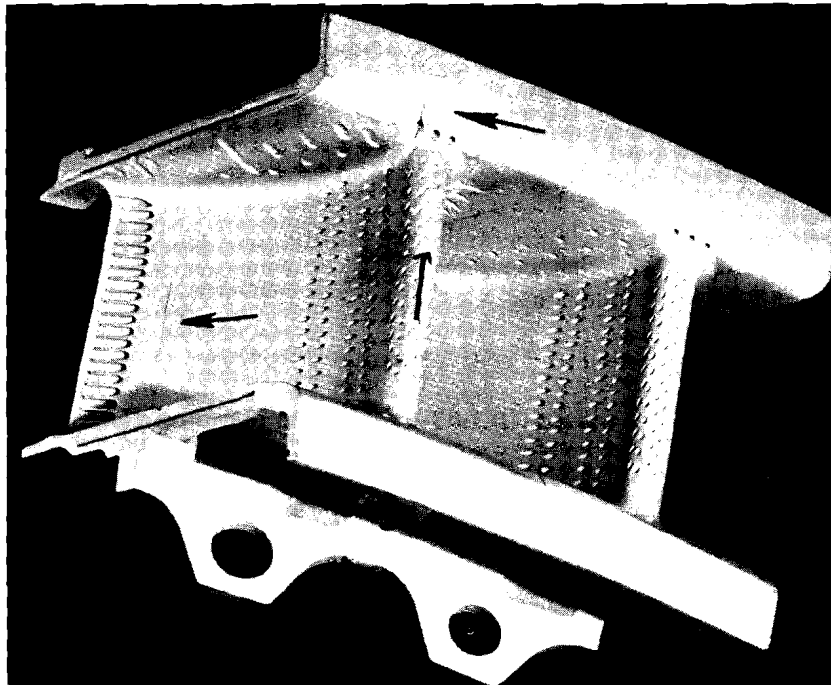
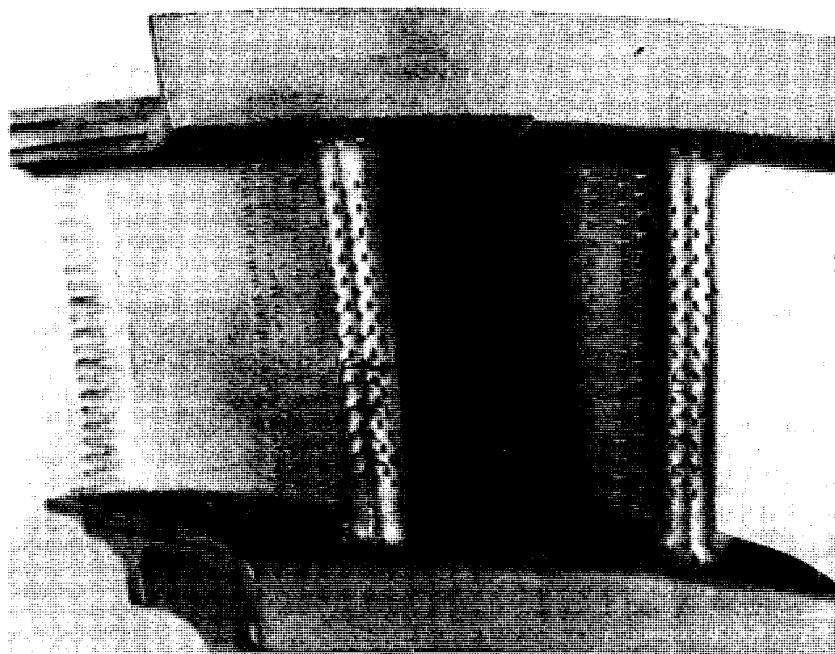
Figure 4. Service Induced Stress in TF39 Stg 1
HPT Nozzle Vanes

- a) Incoming clean - 120 grit Al_2O_3 at 100 psi max.
- b) Identification, bushing removal, and incoming inspection.
- c) Remove inserts.
- d) Hot forming to straighten and restore dimensions.

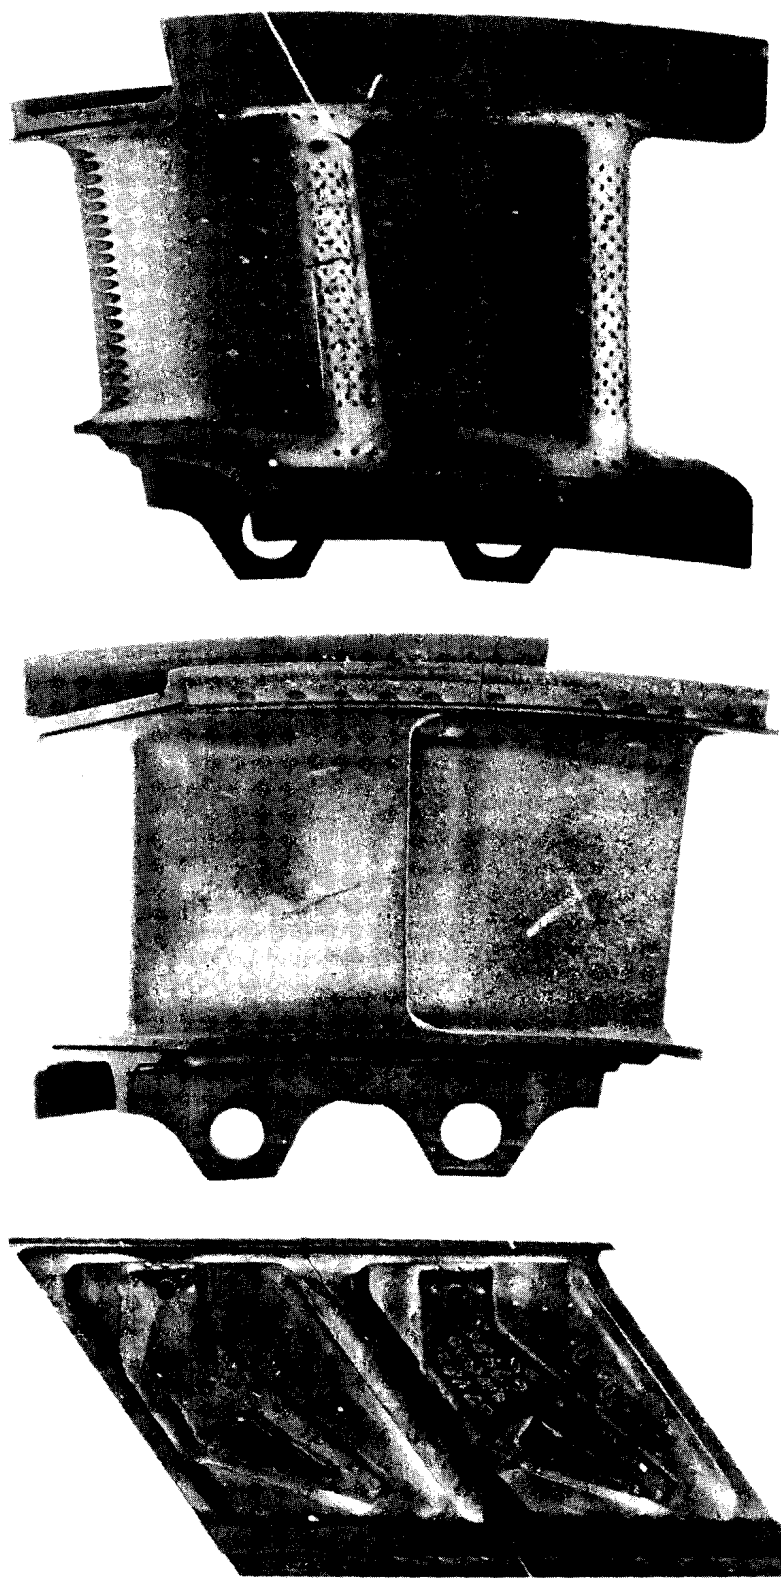
Figure 10. TF39 Stage 1 HPT Vane at Incoming Inspection

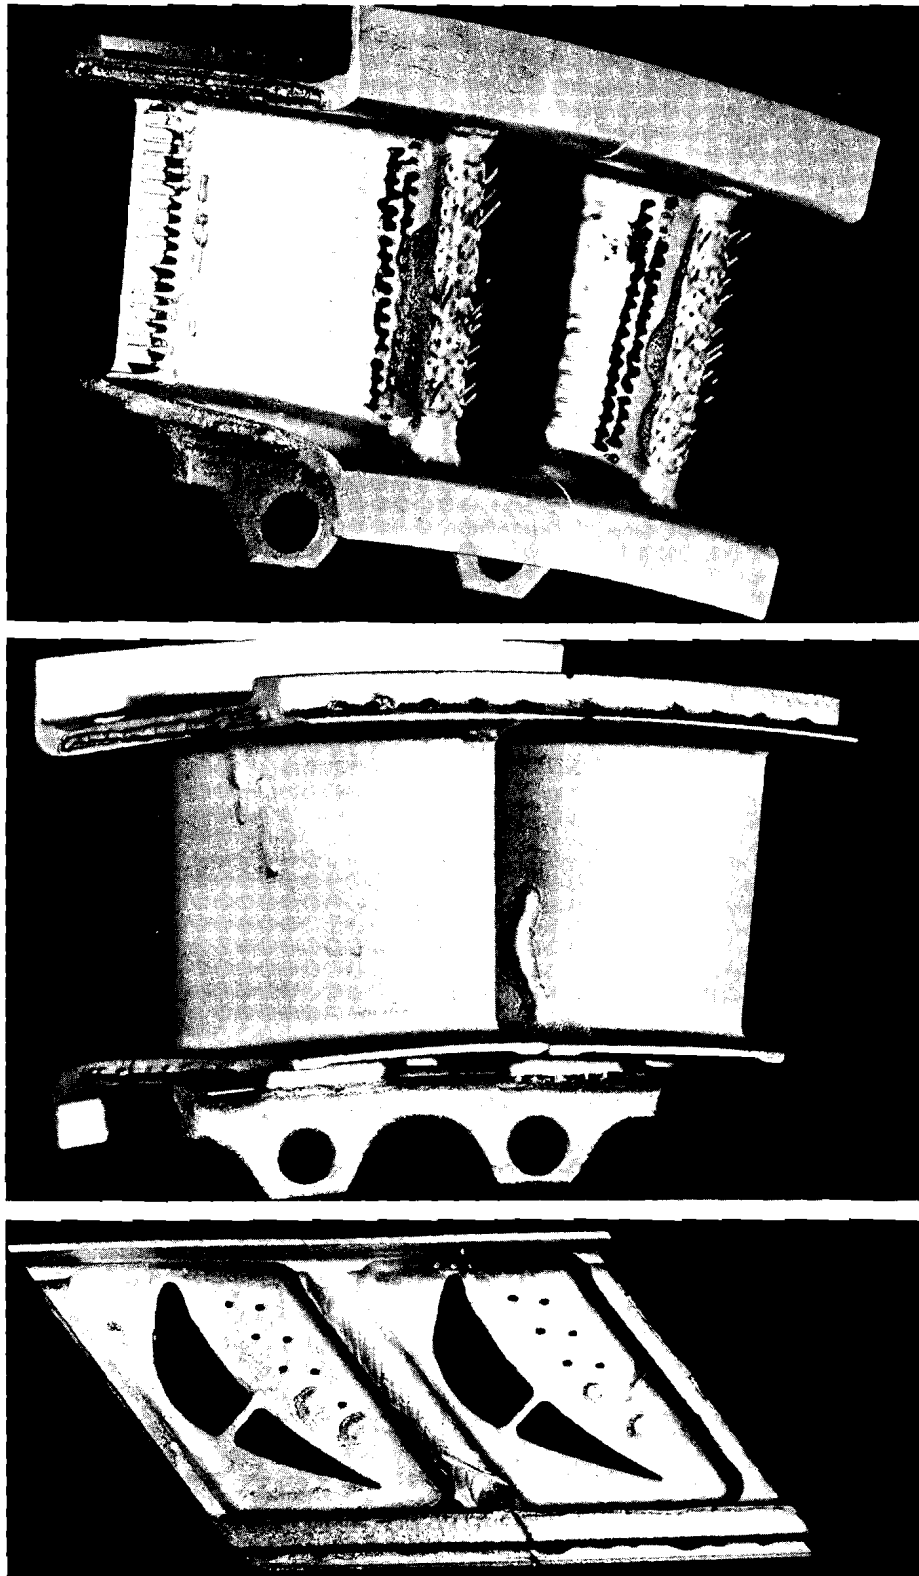
- TOP VIEW - VANE LEADING EDGE. (NOTE QUARTZ PINS IN LEADING
EDGE COOLING HOLES)
- MIDDLE VIEW - VANE TRAILING EDGE (NOTE FLANGE BUILDUP)
- BOTTOM VIEW - VANE OUTER PLATFORM (NOTE FLANGE BUILDUP)

Figure 12. As ADH Repaired Condition of X-40 Engine Run
TF39 Stage 1 HPT Vanes

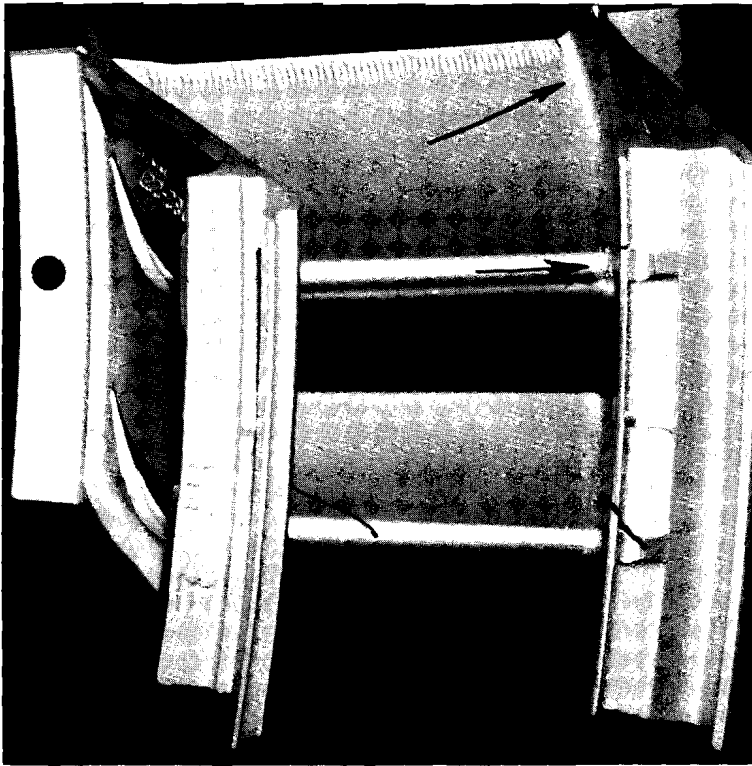
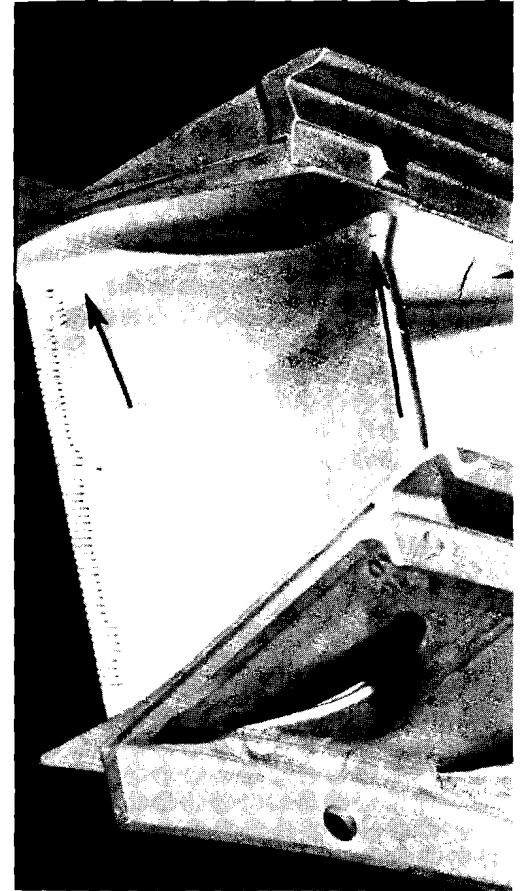
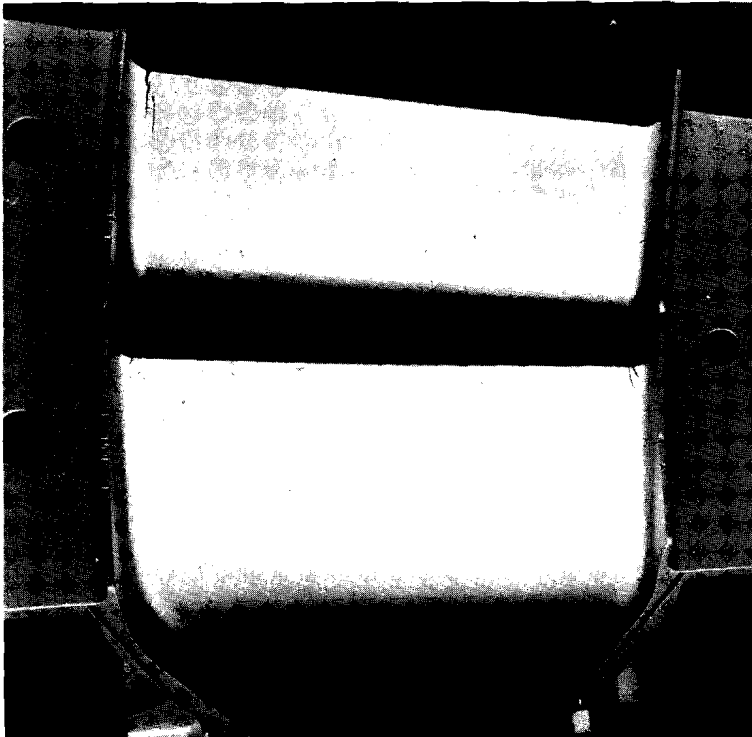
Typical service induced distress is shown in Figure 15. Standard repair procedures call for weld repair with Inco 625 filler. Areas of weld repair are limited in length and location due to (1) low weldment strength relative to the Rene' 80 parent metal, (2) weld distortion, and (3) cracking tendencies of the parent alloy. On a survey sample of 1450 vanes inspected, 37% had defects in excess of the then current weld repair limits.

Figure 15. Appearance of Engine Run TF39 Rene' 80 Stage 2 HPT Vanes After Grit Blast Clean

The goals established for ADH repair were extended to cracks up to 0.040" wide and it was anticipated that this would increase the total of repairable parts in excess of 90%. As with stage 1 vanes it was felt that zone alloying was a more cost effective method for repair of individual cracks than individual crack identification and alloy application. The two significant operations which then required extensive evaluation for process application and substantiation were the fluoride ion cleaning process and the ADH alloy selection and evaluation.

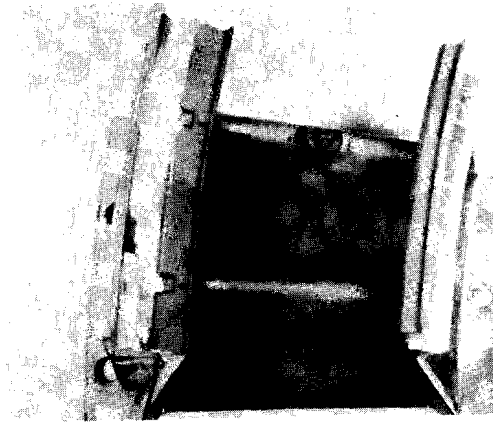
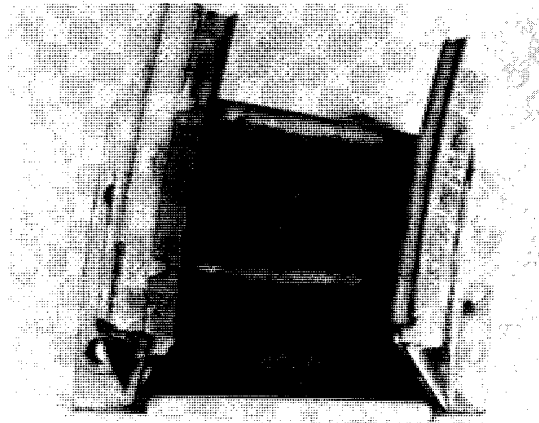
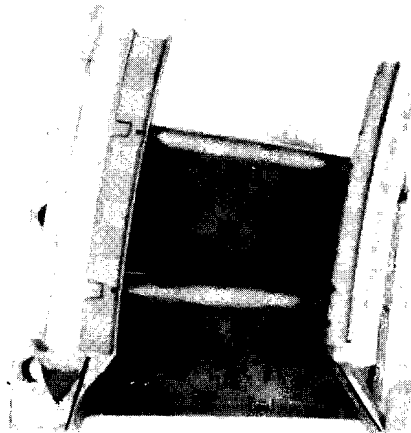
Figure 27. Stage 2 vanes after 100 cycles engine test. All three parts had been stripped F-Cleaned at 1800°F w/CrF₃ plus 2200°F/2 hrs in vacuum, then ADH repaired and CODEP coated.

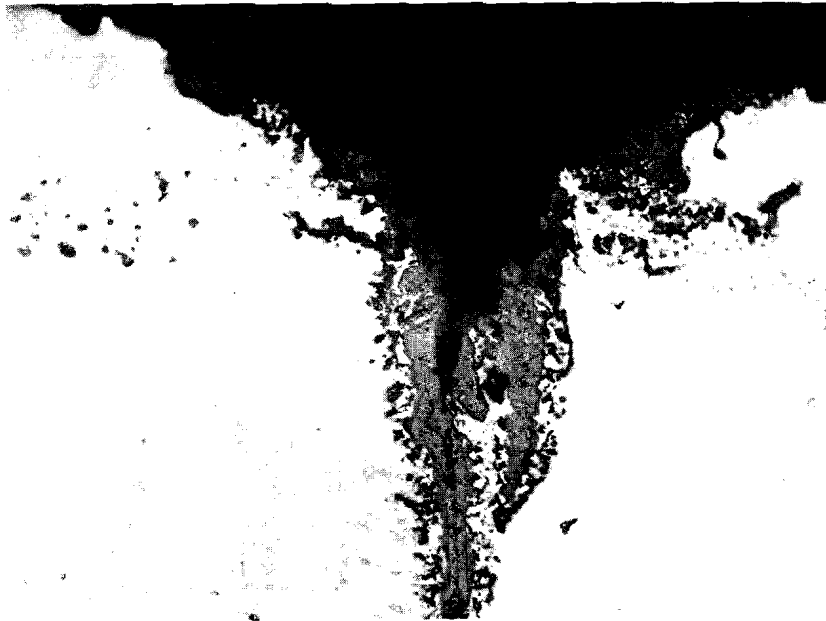
Figure 28. Fluoride Ion Cleaned Vane After 1000 Cycles Engine
Test 500x

A controlled process evaluation was initiated to study this phenomena. Kirkendall voids were not observed immediately after the F⁻ cleaning portion of the process; however, after both subsequent vacuum clean and/or Codep coating, they were observed. This indicated that a diffusion mechanism became operative during the subsequent thermal exposure and affected a rapid diffusion of substrate elements to the alloy depleted surface leaving the observed Kirkendall voids. The oxidation characteristics of the resulting surfaces are shown in Figure 29 along with the normal oxidation of R80 on a stripped and oxidized component. The depleted alloy layer left by F⁻ cleaning and subsequent oxidation testing resulted in catastrophic oxidation attack. Additional thermal exposure in the vacuum clean cycle allowed more diffusion and thus reduced the amount of oxidation attack.

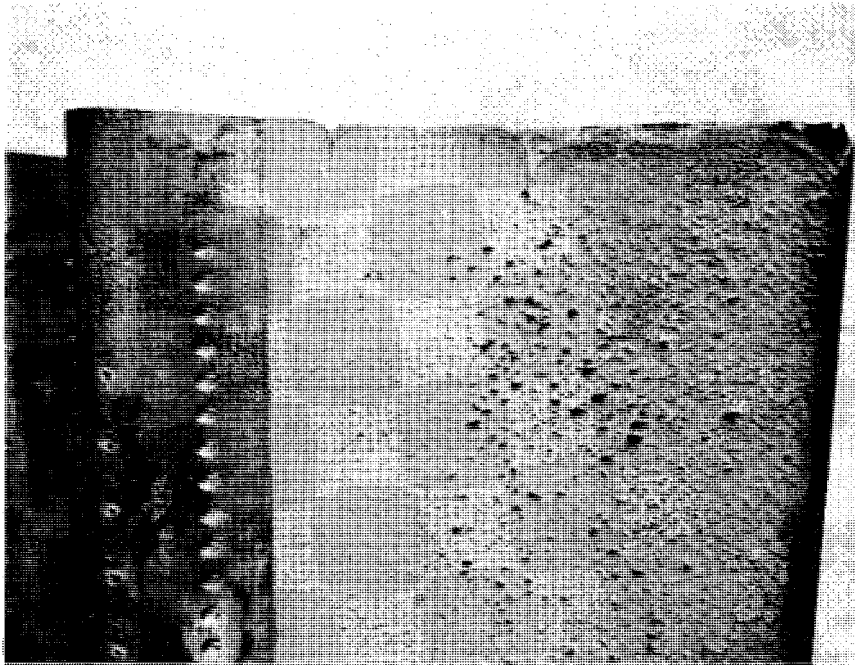
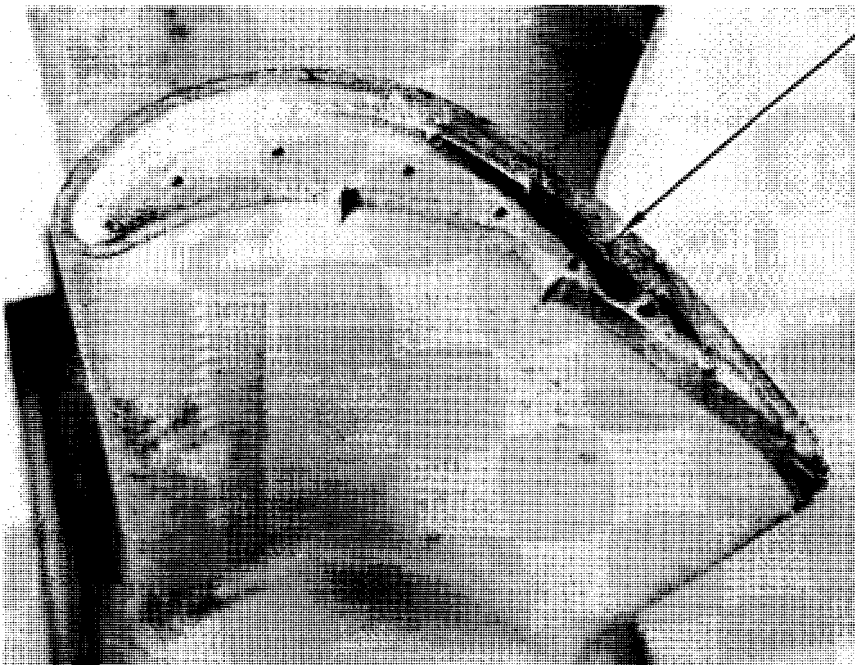
CRACKS THROUGH
TIP CAP

OCCURRENCE
FACTORY \approx 2000 CYCLES

Figure 37. HPTR Stage 1 Blade with Squealer Tip
Cracks Extending Below Tip Cap

- a. Inspect incoming vane airflow.
- b. Strip Codep coating.
- c. Separate paired blades.
- d. Inspect blades to assess damage and repair needs.
- e. Grind tip for mini-bond repair.
- f. Grit blast clean blade tip area.
- g. Vacuum bright anneal blade to finalize cleaning at 2200°F/2 hours.
- h. Dimensional inspect tip cap height.
- i. Assemble tip cap with presintered D-15 ADB alloy to blade.
- j. Mini-bond tip cap.
- k. Dimensional inspect tip cap height for gap upset and visual inspect for complete bonding.
